Cracking up under strain

Effects of non-genuine parts and wrong cleaning

Case story

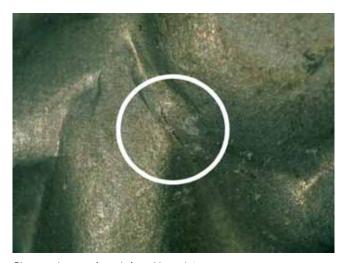
- Fatigue cracks were found in all the plates examined, the result of excess mobility due to incorrectly fitting gaskets.
- The gaskets were too thick (12% thicker than specification) and too hard (by approximately 8%).
- The gaskets were made of an incorrect material (EPDM instead of NBR) with an IRHD hardness rating different from specifications.
- Three of the plates had been partly dissolved by chemical action. This was probably due to the service company having used incorrect cleaning procedures featuring an aggressive cleaning liquid such as hydrochloric acid.

- The oversized gaskets had prevented the plates from coming into proper contact with each other and had thus caused widespread leaks.
- The extra thickness and hardness of the gaskets made it impossible to assemble the heat exchanger correctly, adding 285 mm of extra material to the length of the plate pack
- Insufficient contact between the plates meant that the plate pack lacked its full strength. Inadequate support resulted in plates flexing, causing fatigue and leading to numerous cracks.
- Non-branched fatigue cracks of different lengths were found in almost all the plates examined.

Close-up image of crack found in a plate.

As a result, every single gasket had to be replaced, as well as many of the relatively expensive titanium heat exchanger plates.
